US Army Corps
of Engineers
Seattle District

Construction Foundation Report

Mud Mountain Dam Seepage Control Cutoff Wall

CONSTRUCTION FOUNDATION REPORT
SEEPAGE CONTROL WALL
CONTRACT NO. DACW67-83-C-0047

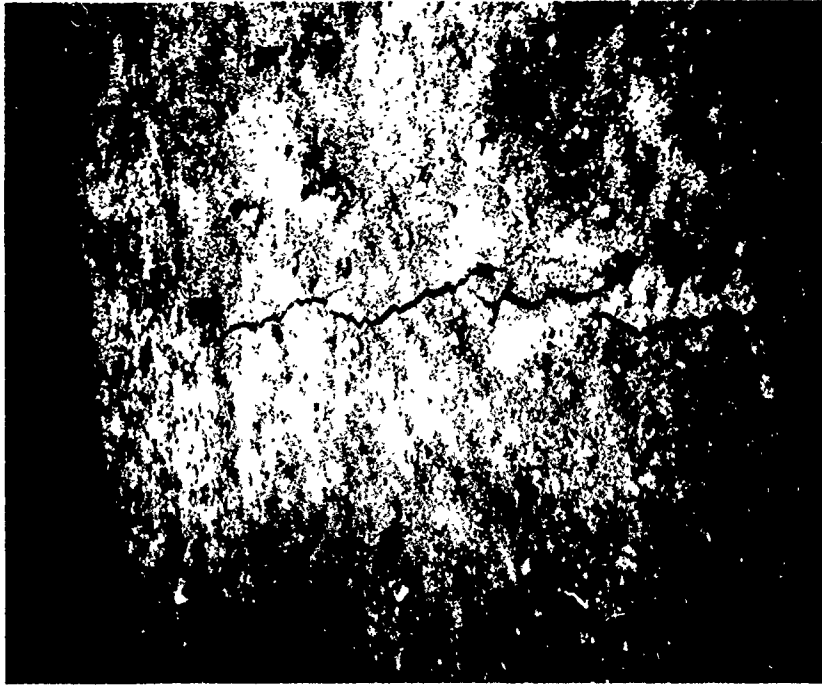
Cracks on work platform running longitudinally across dam. Micro-cassette recorder for scale. Looking toward left side, cutoff wall about 10 ft. left. Left side is dropping down. Looking at area around station 14+50.

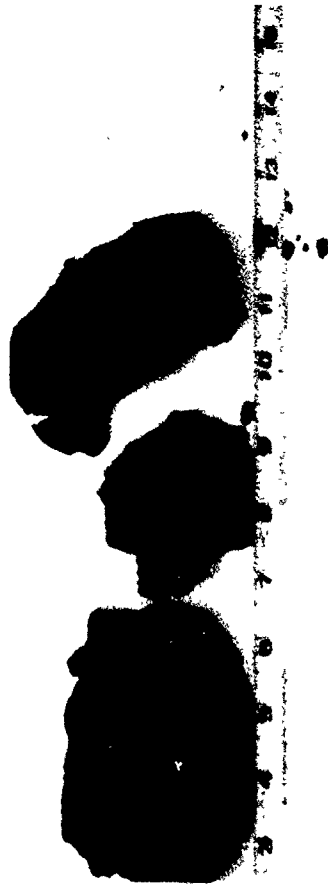
Core fragments from station 15+30 showing bentonite filtrate cake left from repeated hydrofracture occurrences. Note "double event" recorded at 8 inch mark.
